Assessment of Road and Surface Water Drainage Condition in Urban Ethiopia, with Special Reference of Assosa Town

KOKEB ZENA BESHA

ADDISU ADAMU ALEMAYEHU

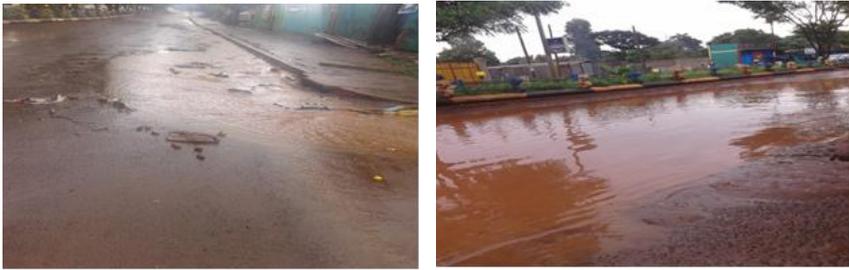
In Asosa town, because of inadequate drainage, poor maintenance and lack of sufficient road profile, a significant part of the water accumulated on road pavement. The surface water from the carriageway and shoulder should not be drained off, and runoff water from the adjoining land easily enters to the roadway because of poor drainage provision. The existing side drains did not have sufficient capacity and longitudinal slopes to carry away all the surface water collected. This improper drainage system causes the failure of road pavements by increase in moisture content, decrease in strength, mud pumping, formation of waves and corrugations, stripping of bitumen, cutting of edges of pavement and so on. As shown in figure a street flooding affects pavement performance and obstructed traffic flow.

Figure 1: Ponding of water during rain on road surface near to Assosa town Administration Office

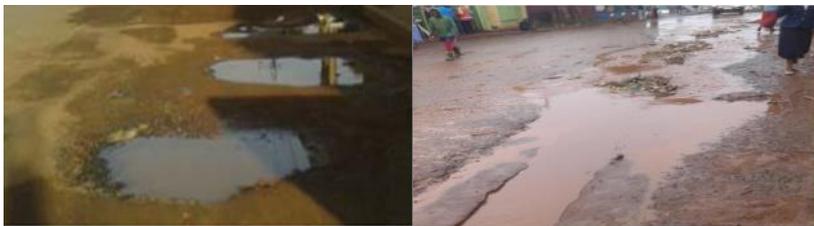
Water has a number of unhelpful characteristics which impact on road performance. The road surface, cross-section slope, longitudinal gradient and shoulders were investigated and different types of damages were observed at the study area. These are depressions, potholes, cracking, over flooding, pavement erosion, silt & sediment accumulation, washing and deformations of the road pavements. Figure 5 shows the severely deteriorated road surface.

Figure 5: a) Ponding of water on potholes b) Surface Runoff on road pavement

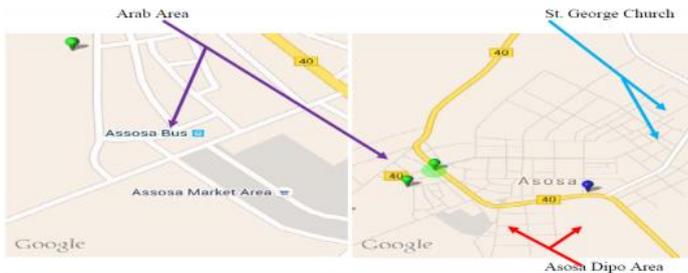
Figure 9: Major Flood Sensitive Areas at the study area

5. Considering the slope of the area and runoff condition, it is recommended that provide drainage system starting from in front of Bamboo Paradise Hotel and Ethiopian Red Cross Asosa Branch to Prison of Asosa, and also starting from Asosa St. George Church along with Tena Area to the natural channel or St. Michael Church, construction of large drainages could effectively reduce the surface run-off during a strong rainfall event.

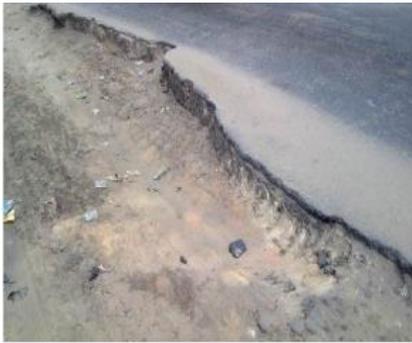
Edge Failure

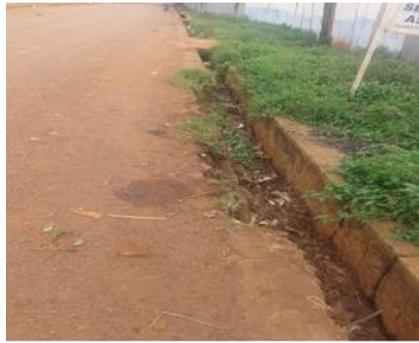
Severely failed side drains

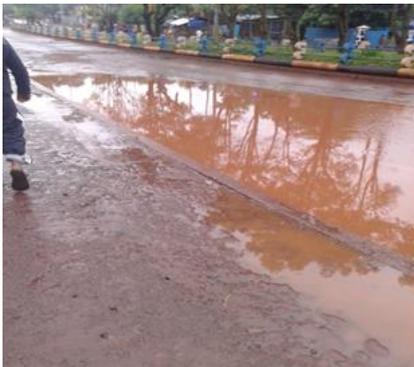
Flooded road

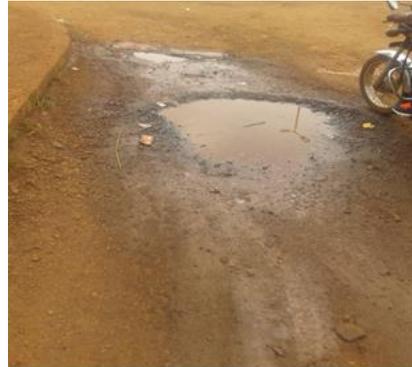
Potholes on Road Pavement

The bad condition of the side drain and its structures remains the same at the study area throughout the year causing the runoff water to flow on the surface of the road and formation of potholes (Figure11) and unable to run off through the path far from the failed drain. The road edges suffered from detachment of asphalt layer due to continuous contact of water leading to stripping of asphalt from aggregates resulting in severe pavement distresses of cracking, potholes, patches and failure of edges. In addition to these, bad smell and environmental pollution, urban land degradation, development of disease causing organisms were some of the findings as a result of inadequate integration between road and urban drainage infrastructures. Whatever the infrastructures like roads, drains

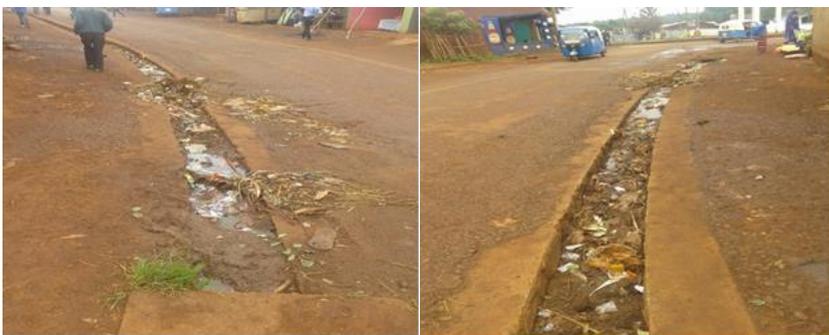
It is also observed that most of the side drains are full of sediment and garbage at many places which obstruct the normal flow of water in the channel. Some drains are also covered with grasses and shrubs and thus not giving the desired function for which it was constructed. Figures 13 presents proof of this reduction in service lifespan and it is evident in the deterioration of drainages and subsequent road pavement conditions which are visibly noticed in the form of edge failures of road pavements, pot holes on road pavements, stripping of bitumen off the surface of road pavements and blockage of drainage channels such as culverts and underground drainage networks. Also these poor maintenance culture results in gullies and gratings being blocked with dirt weed, silt sand accumulation over time and in the growth of vegetation inside and around the side drains which has resulted into total failure of the side drains structures.

Fully Blocked Drains

2. Existing urban storm water drainage infrastructure condition in the town is not satisfactory. Hence, practical measures should be taken to reduce and manage flooding hazard (like, clearing of drains, maintenance of drains before the rainy season begins and providing additional drains)

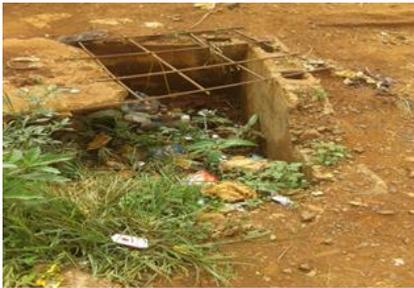
Failed manhole

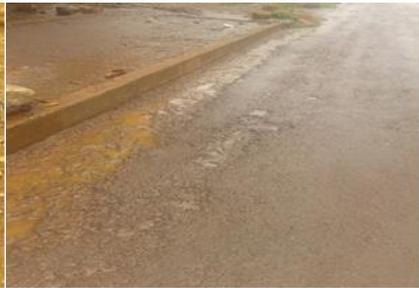
Eroded pavement surface

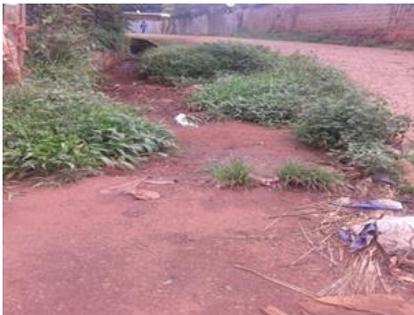
Drains covered by Grass

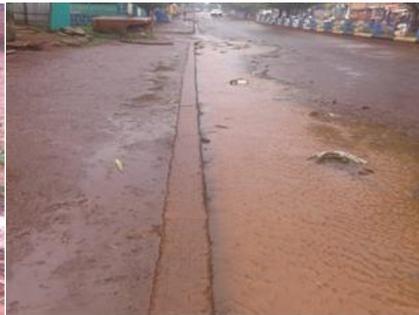
inadequate sizes

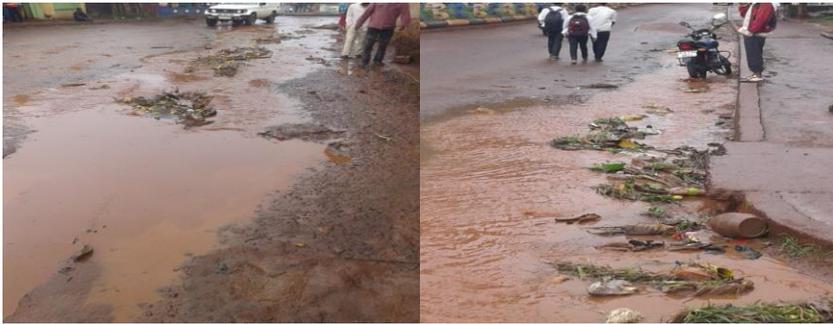
On the other hand, a significant part of the existing drainage channels are partially (in some areas fully) filled with solid waste of different varieties. And in most of the junctions or inlets, there is no silt trap mechanism and because of this any material from the surrounding areas are transported by surface runoff into the storm drains which reduces its effective carrying capacity.

Street Flooding because of drains blockage

3. Improvement on the integration of solid waste management system to prevent over flowing of flood as a result of blockage of drains.

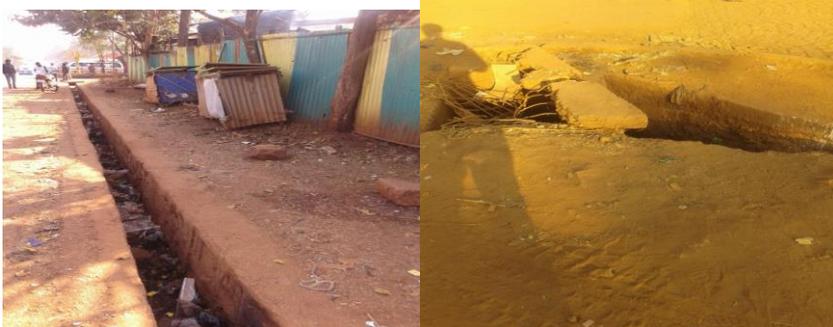
Waste materials in side drains

failed side drains
