Assessment of the Quality of Urban Roadside Walkway Environment: *the Case of Assosa Town, Benishangul Gumz Regional State of Ethiopia*

KOKEB ZENA BESHA

Lecturer, Department of Civil Engineering
Assosa University, Ethiopia

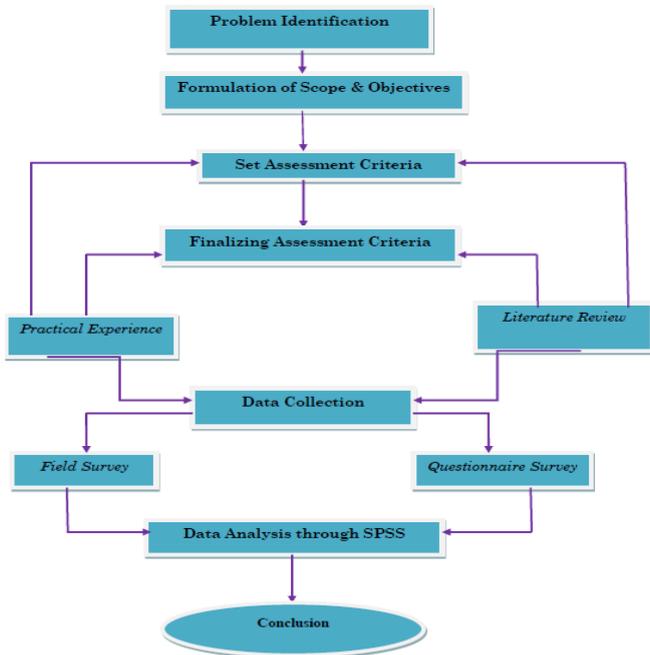
Figure 2: Methodology of the Study

flowchart of methodology given below, describes the systematic procedure of the study.

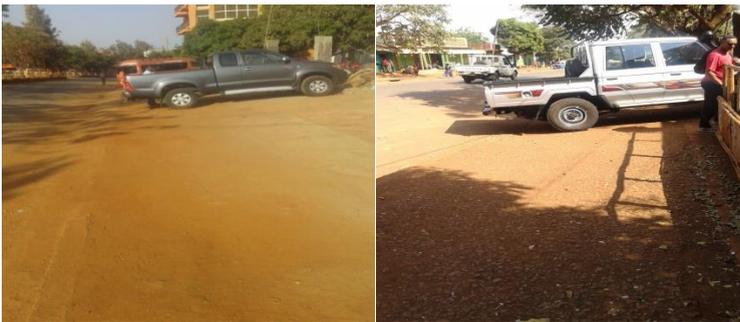
Figure 3: Illegal parking on the sidewalks

Illegal Parking: this comes at as an acceptance level in the study area. But it is not at its best because observation survey clearly shows at some city centres that drivers park their cars longer times when they visit hotels, restaurants, bars and shops. It creates hindrances for the pedestrians and this implies less safety for them on sidewalks. This unwanted situation forces pedestrians to invade on adjacent traffic lanes. During the market day, many people are coming from the nearby settlement and rural areas for exchanging commodities , as a result of this the shopkeepers want to show their products to the walkers to promote their businesses and in some city centres they blocked the whole width of the roadside walkways (figure 3).

Considering figure 3, illegal parking has taken almost the whole parts of the sidewalk width especially at Bamboo Hotel, in front of Asosa bus station and other areas. The pedestrians put their impression in the scale and it implies that the authentic town of evaluation follows similar evidences in line with the observation survey.

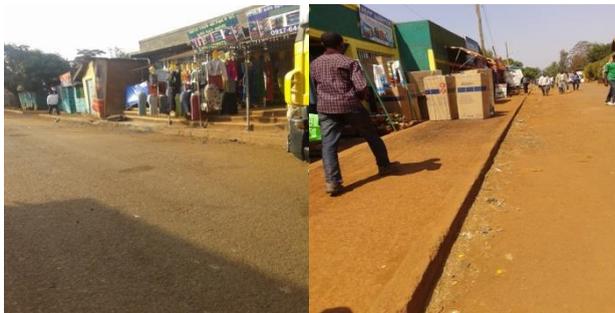
Figure 4: Illegal Encroachments by illegal Vendors on Sidewalks

Encroachments: illegal encroachment of hawkers on the footpaths in the commercial areas (like bus station, market areas, on arterial roads) is serious problem. Vendors spread their wares on the footpath and eventually reduce the effective width of footpath. Besides encroaching on the sidewalks, having vendors along the roads also increases pedestrian traffic. Moreover, vendors and shoppers are often distracted and not fully aware of the vehicular traffic. Figure 4 shows observation views of illegal encroachments at some city centres of Asosa.

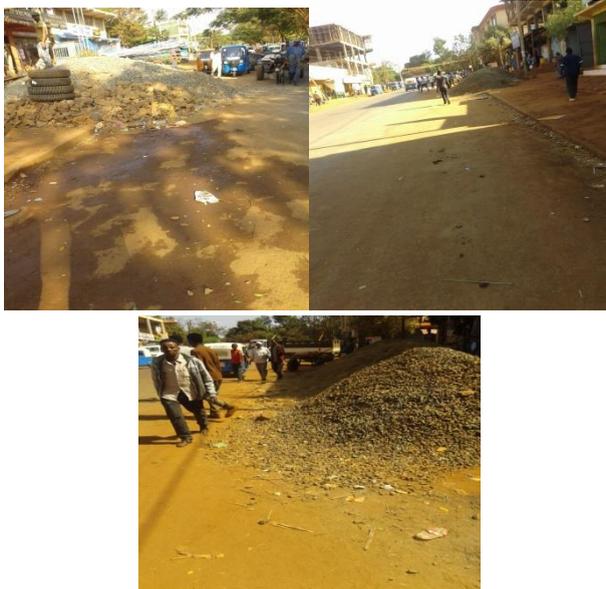
Figure 5: Illegal Encroachments on sidewalks by building materials

On the other hand, encroachment of sidewalks by building materials is also a common occurrence in many parts of the town. There are a lot of large waste bins on the streets close to the footpath in most of the links observed in our study. These waste bins cause addition problem to pedestrians because the garbage stored in them often overflow onto the streets and footpaths thereby creating more safety hazards. Figure 5 represents the picture of building material encroachments of the sidewalks.

Observation survey reveals and as indicated in figure 5 that improperly allocated construction materials on the sidewalks can pose safety issues for pedestrians by blocking the sidewalk and creating alternate routes that are less accommodating for pedestrians. As it can be seen from the above figures, illegally dumped construction materials take almost the whole width of the sidewalks and create serious safety problems for the pedestrians. To know the views of the pedestrians for encroachments, we made questionnaire survey with the walkers and their impression can be presented in table 3.

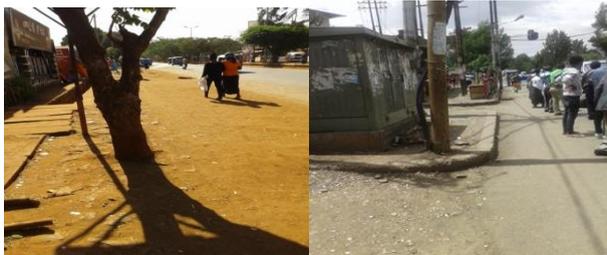
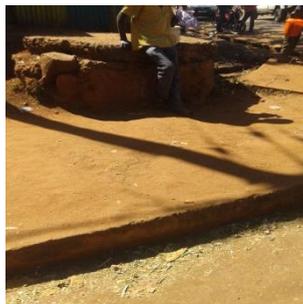
Figure 6: Common Causes of Hindrance at the Study Area

The most common types of hindrance observed at the study area are trees, dustbins, utility poles (electric and telephones) and unwanted elements or items on sidewalks. The photo taken during the observation survey can be evidence for this study.

a) *Tree on Sidewalk*

b) *Utility poles on Sidewalk*

c) *Unwanted elements or items on sidewalks*

As it is observed in figure 6 (a & b) improperly allocated utility poles and trees almost makes it impossible to the walkers to walk comfortably on sidewalks. The pedestrians must down their heads to avoid the trees when walking on the sidewalk. This situation creates uncomfortable walking environment. In figure 6 C, unnecessarily placed concrete block makes the walkway environment uncomfortable for the walkers. In some areas, there is not enough lighting on streets. At night, these trees, electric poles and concrete blocks create even more inconvenient walkway environment.

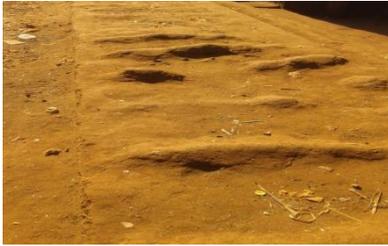
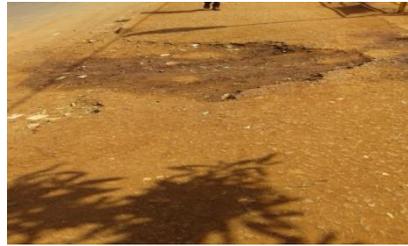
Figure 7: Poor Quality of pedestrian Walkways

During the observation survey, it is seen that the surface of the walkways are damaged and offered muddy environment in the rainy season, covered by soil and presence of highly rough surfaces and difficult to identify from the roadway. As a result these problems the walkers use the carriage instead of the roadside walkways and they exposed to accidents. Besides, when rain drops the roadside walkways do not clear and drain the rain waters quickly rather storing the water on potholes and forming muddy condition. People cannot see if there is any small hole or broken surfaces which offer less safety in the

Highly rough sidewalk

Potholes on Sidewalks

Soil Accumulation

As shown in figure 7, the roadside walkway is full of mud, soil and presence of wastes. In the first figure, it is covered by soil and difficult to identify from the road way. Based on this study, 56% of the walkers do not want to use the footpaths for walking in the town because of the presence of mud, soil, potholes & patches and highly rough surface. As a result of the stated factors, walkers do not use the sidewalks rather they feel convenient to use the road space and many accidents take place indeed.
