The Effects of Inadequate Urban Drainage System on Pavement Performance in Ethiopia

KOKEB ZENA BESHA

Assosa University, South Western Ethiopia

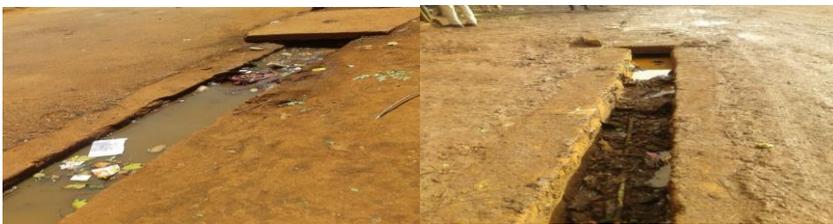
Inadequate Drain Size: Most of the drains are with small cross section of about 0.4m width and not more than 1m depth. Such types of drains are incapable to discharge the storm water safely and cause street flooding during the rainy seasons rather over flowing. These challenges do not only retard storm water flow in the drain, but they also increase overflow and street flooding conditions.

Figure 2: inadequate drain size accompanied by water logging

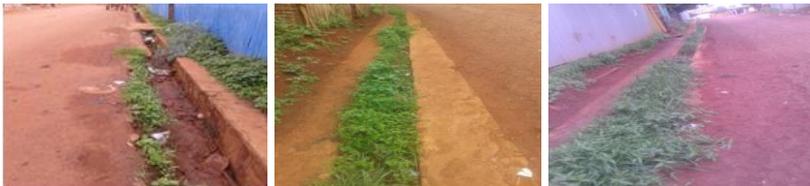
Structural Failure: As a result of poor maintenance, workmanship, material quality and poor supervision, existing drains and its structures is collapsed before design life. This situation affects the road pavement by diverting the storm water and soil & sediments towards the road ways. Figure 3 shows a collapsed drain which is unable to perform its intended purpose. As we observed in this drain, weeds & grass are growing, sediments are accumulated.

Figure 3: Collapsed & vegetated concrete drains

The soils deposited in the drains provide substrate for the growth of vegetation which further restricts drainage down slope. Following the vegetal growth in the drain, debris collected by the road wash is wedged in it thereby compounding the flow situation.

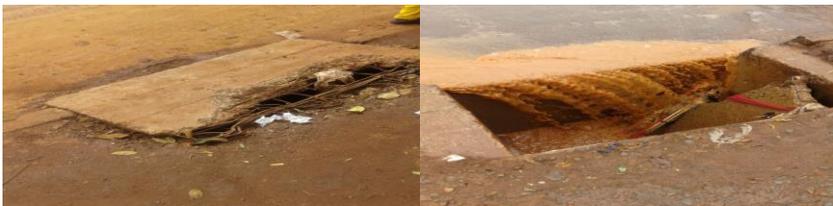
Blocked Drains: in most areas of the town, the manholes and culverts are blocked with silt and sand accumulation. Culverts and manholes are converted to dumpy place and subsequently obstructed the storm water flow. In figure below (right), the cover of the manhole is submerged inside the hole & water flows over pavement which erodes the edge.

Figure 4: Failed manholes of side drain due to poor maintenance

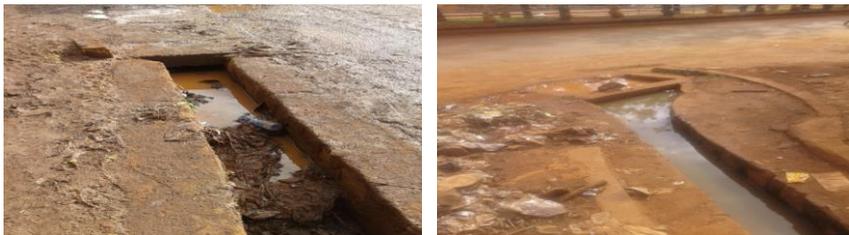
In addition, the drain is often used as refuse disposal channel by residents, creating very poor sanitary condition. It was observed that the side drains were full of dirty water and refuse dumps. The inlets on the curb were blocked with soil & silt accumulation as shown in figure 5. No regular maintenance for the drains was observed throughout the year.

Figure 5: Blocked drains at Dead Ends

Some of the drains have dead ends such that transflow hardly occurs. As a result, sustained flooding of the area after a torrential rainfall is common. This provides breeding ground for mosquitoes which thrive on stagnant water, introduces other water associated health risks, and promotes structural failure of the adjacent road pavement.

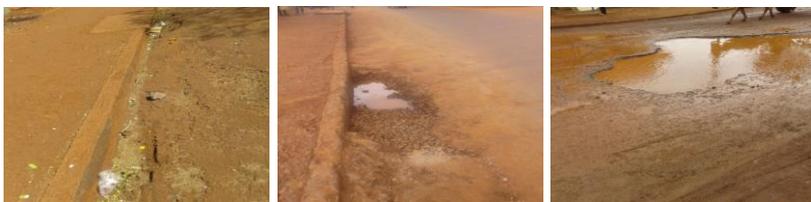
Formation of Potholes: Structurally, most of the side drains are at bad condition and the resultant effect of this critical situation causes serious distresses and damages on pavement. The road edges suffered from detachment of asphalt layer due to continuous contact of water leading to stripping of asphalt from aggregates resulting in severe pavement distresses like potholes, washed pavement and edges failure (figure 6).

Figure 6: Severely failed edges and formation of potholes

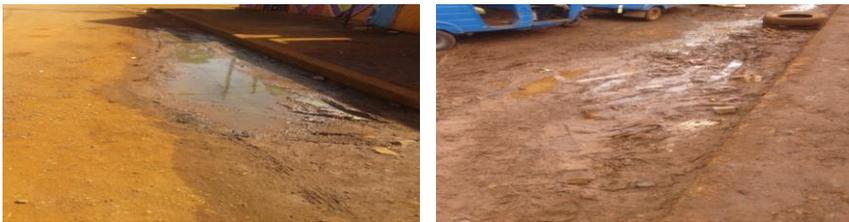
Silt & Sediment Accumulation: Even after a little rainfall there is a formation and transportation of mud, silt and soil on the pavement and its edges. These unwanted materials are coming from failed, deteriorated and poorly maintained side drains & their structures. Pavement failures like potholes, ravelling, depressions, and silt sedimentation on depressions were followed as shown in figure 7.

Figure 7: Silt & mud pumping on road pavements
