Accessibility for Pedestrians: Evaluation of school area in the Northern Zone of Manaus

Key words: Accessibility, Pedestrians, Pedestrian Circulation System, Sidewalks.

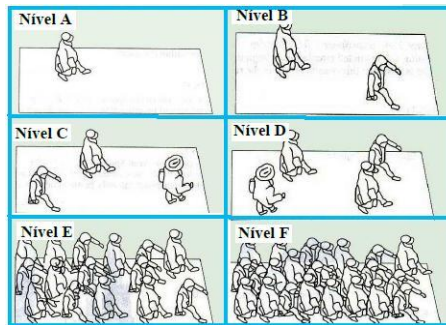
Figure 4, below, exemplifies the service levels quoted above:

Figure 4 - Service levels for pedestrians on the move. Source: Adapted from HCM 2000.

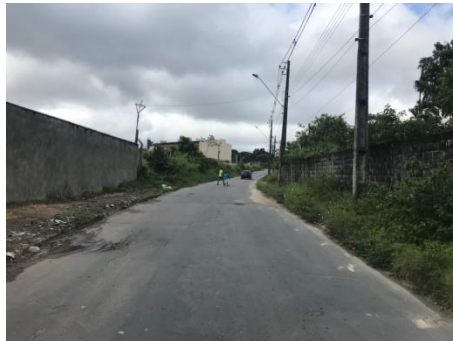
Figure 5, below, shows an excerpt from the pathway of the study site, located between the two schools.

Figure 5 - Public thoroughfare at the study site. (Av. Santa Marta, Jesus me Deus Community, Colônia Terra Nova, Manaus, Amazonas). Source: Own Author.

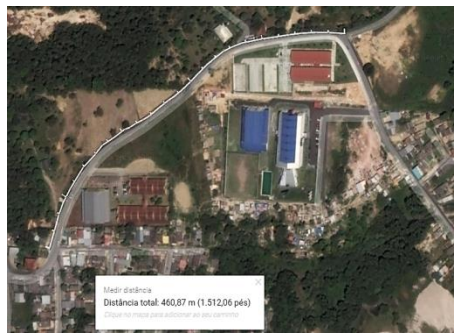
Figure 6 - Excerpt delimitation 1. Source: Adapted from Google Maps

- Length: 460,87m
- Width of the walk: 1,20m

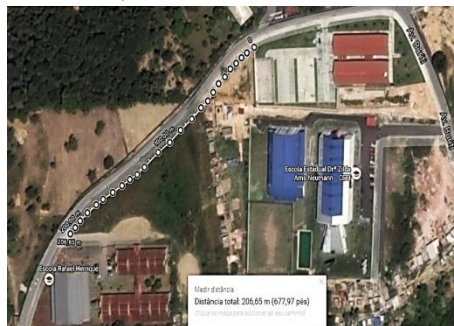
Figure 7 - Outline delimitation 2. Source: Adapted from Google Maps

- Length: 206,65m
- Width: 2.20m

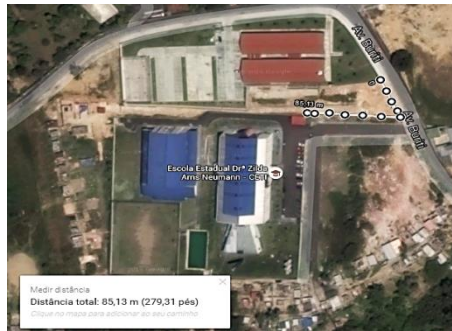
Figure 8 - Delimitation of the Section 3. Source: Google Maps

- Length: 85.13m
- Width: 2.20m

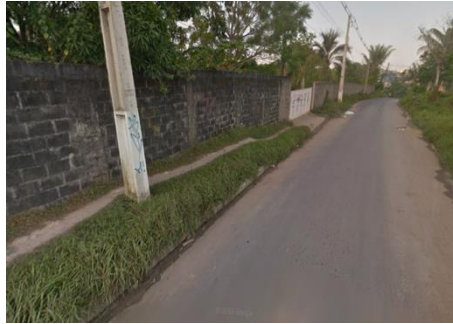
With all the post holes made and compacted, start the process of withdrawing the 14 posts of section 1 and installing them in section 2. This process of reallocation of the posts happens because 'Section 1' is only one meter wide for execution of the tour. If there are posts in this section, the tour will be unviable for pedestrians, as recommended by ABNT NBR 9050: 2015. Figure 9, below, shows the current situation of section 1:

Figura 9 – Postes sobre o passeio (Trecho 1). Fonte: Google Maps

This service must be performed by the electric utility, with prior request prior to construction, for the safety of all users of the public highway. At the end of the relocation, finish the movements on land with the backfill of the open spaces of the open ditches, up to the level of the walk.

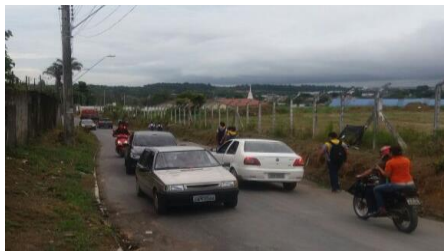
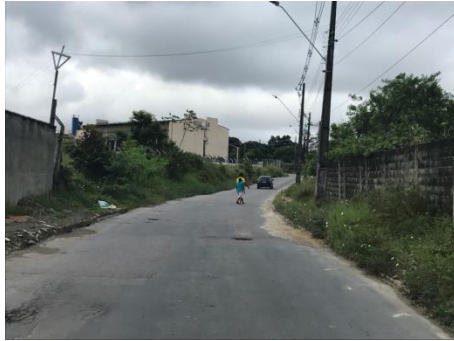
**Figure 13.1 - Section 1 (left) and 2 (right). Next to the State School Rafael Henrique.
Source: Own Author. Year: 2016.**

Figure 13.2 - Section 1 (right) and 2 (left). Next to the State School Rafael Henrique. Source: Own Author. Year: 2018.

Figures 13.1 and 13.2 present the same excerpts and we can see that there were changes, but nothing significant. The pedestrians still continue to travel on the road, since the rides still do not have continuity.

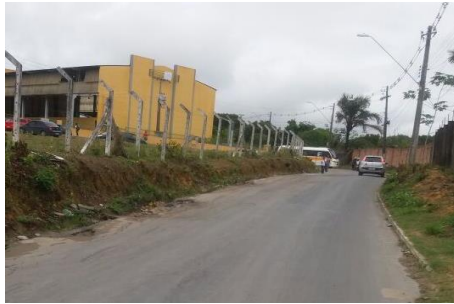
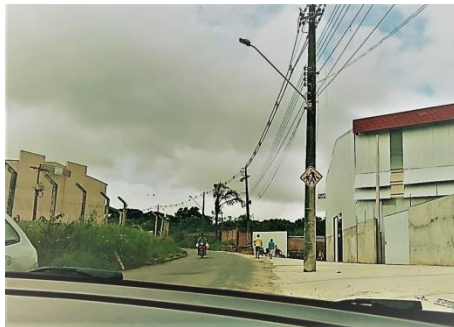
Figure 14.1 - Section 1 (right) and 2 (left), near the Rafael Henrique School. Source: Own Author. Year: 2016

Figure 14.2 - Section 1 (right) and 2 (left), near the Rafael Henrique School. Source: Own Author. Year: 2018

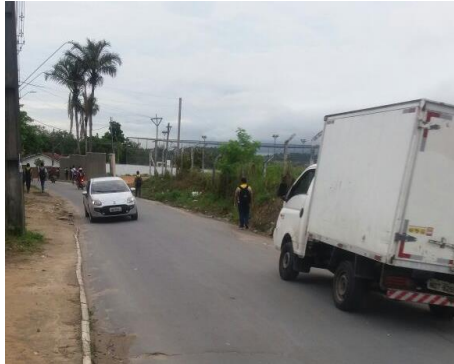
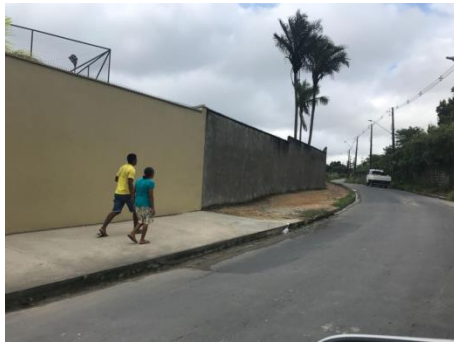
Figure 15.1 - Section 1 (left) and 2 (right) near the Church of the Saints of the Last Days. Source: Own Author. Year: 2016.

Figure 15.2 - Section 1 (right) and 2 (left), near the Church of the Saints of the Last Days. Source: Own Author. Year: 2018.

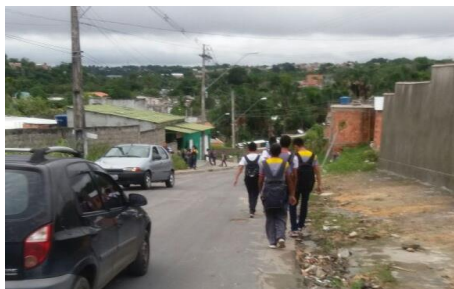
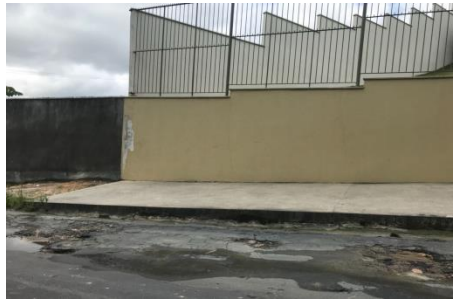
Figure 16.1 - Section 3 (right), near CETI Dr. Zilda Neumann. Source: Own Author. Year: 2016.

Figure 16.2 - Section 3 (right), near CETI Dr. Zilda Neumann. Source: Own Author. Year: 2018.

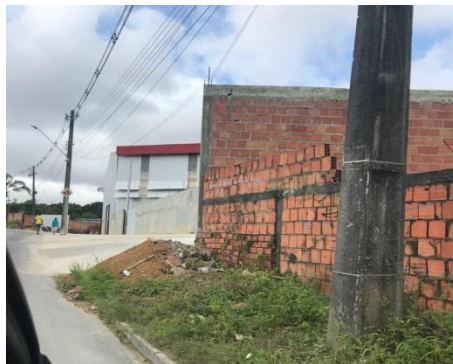
Although they are paved, they have uneven holes and surfaces during the whole course. The stretches of access to the walks do not have ramps for wheelchair users. The transverse and longitudinal inclinations are in accordance with NBR 9050: 2015.

It is possible to walk in some parts of the sections without finding obstacles or something that can intervene in the normal process of pedestrian circulation, but, due to the lack of continuity, when it is shown in figure 17, it is impossible to continue traveling on the walk, especially for those who have less favorable mobility conditions.

Figure 17 - Excerpt 1 - Lack of continuity of the ride and several obstacles on it. Source: Own Author. Year: 2018

In order to address such issues, it is recommended that an urban mobility plan be developed and implemented for the accessibility of pedestrians, such as: accessibility and infrastructure of sidewalks, signaling, and that there is considerable free movement of pedestrians and sidewalks, so that the free track is not obstructed by weeding according to the figures above.
