Disordered Urbanization: Analysis of a Slope in Recife/PE

Abstract:

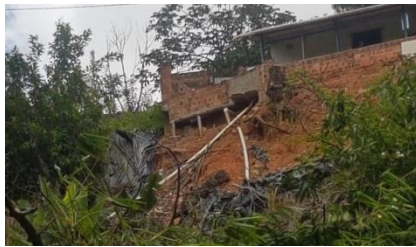
Figure 7: Discharge of sewage directly into the ground.

The absence of a health network increases the volume of sewage that is released directly to the ground, resulting in a reduction in its shear strength. It was observed that most of the houses discharge sewage directly to the ground, without any kind of care, making the environmental indicator “absence of sanitation network” an indicator of a high degree of risk (Figure 7).

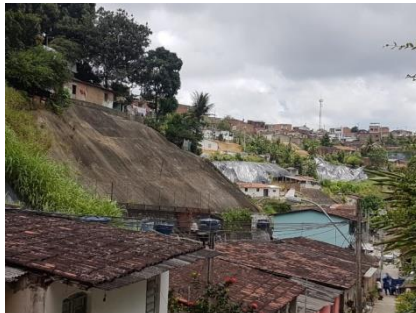
Figure 8: Buildings along the slope.

At the site, there are constructions along the slope in places considered to be high risk, in which it is possible to analyze the absence of urban planning (Figure 8). These constructions on the slope increase the overload on the land and the mobilizing tensions, making the “type of occupation” indicator an indicator of high risk.
