Temporal Analysis of Coastal Erosion and Environmental Degradation at Suape Beach

Abstract

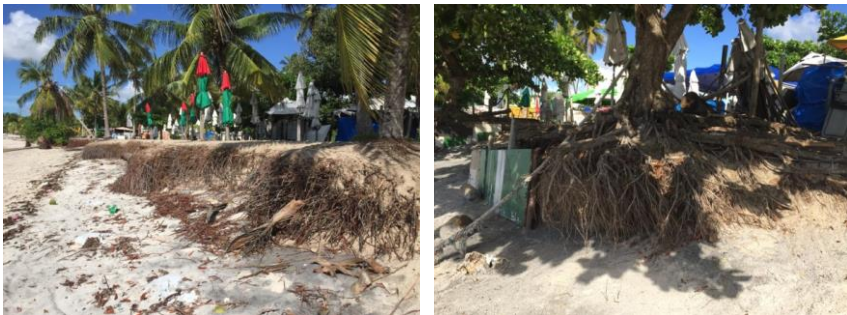
Figure 9 – Trees on the beach face with exposed roots.

The use of indicators (evidences and indices) of coastal erosional processes is an alternative for carrying out erosion risk assessments in coastal areas (MARTINS et al., 2016). Souza and Suguio (1996), Martins et al. (2016) and Menezes (2016) determined geoindicators of erosional processes, some of them were found in the study area. Figures 9 to 12 show some of the geoindicators found on Suape beach.

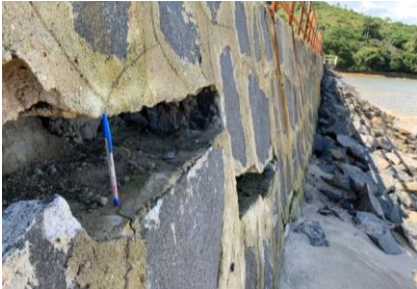
Figure 10 – Erosion marks at the walls.

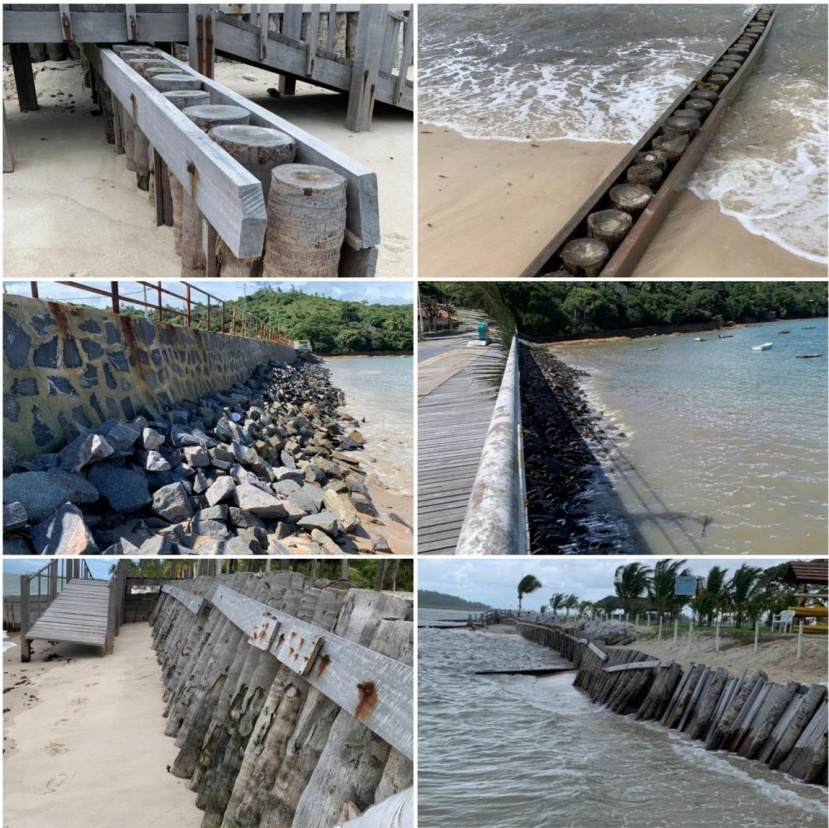
Figure 12 – Presence of coastal protection structures
