Global Gravity Index (IGG) of a Stretch of a Street in the Amazonian Capital

Abstract

Thus, this article aims to calculate the global severity index of a stretch of a street in the city of Manaus, objectifying the real situation of the location to describe whether it is a satisfactory stretch for traffic or not.

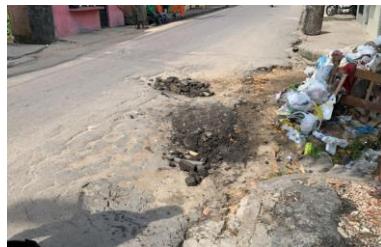
Image 02 – Location of the pathology. Source - Own

Along its axis, the present street has a number of pathologies, however in image 02 one of the pathologies present attracted great attention due to the complexity of its possible causes of problems.

Image 02, it is possible to verify the pathology empirically, in a brief evaluation in loco, the authors can suggest a problematic pathology related to isolated Cracks of the longitudinal type and Sinking By Consolidation, the reason will be given by:

Isolated longitudinal cracks: The empirical evaluation suggested that the cracks present had an opening greater than 05 cm, and because of the similarity that the image that the DNIT standard presents.

Consolidation sinking: In view of the detailed reading of the regulation of the DNIT 006/2003 standard in force, when looking at the type of execution that is possible to recover the stretch, only the consolidation sinking that exemplifies the relationship of a possible recovery to the sub-grade of the paving, this statement is possible because when carefully observing the section, the asphalt coating that was removed, the sub-base layer is already observed, thus suggesting that it will not only be necessary to repair the asphalt layer, but the layer bottom.

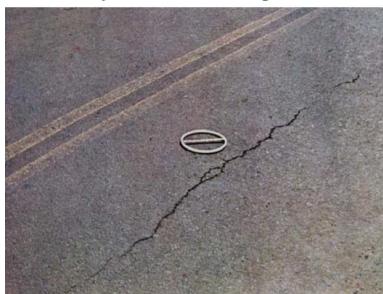
Image 03 - Standard DNIT 005/2003

In images 03 and 04, it is possible to verify the similarity of the description that the standard cites (Image 03) with the crack present in the field (Image 04)

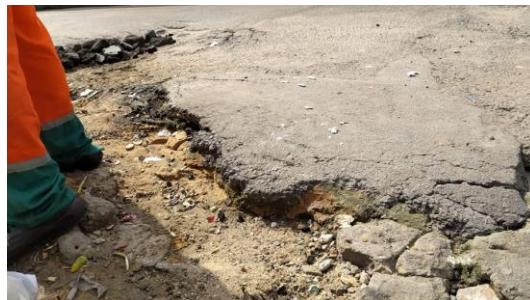
Image 05 – Pathology location. Source – Own.

In image 05, we can see that not only the presence of cracks are causing the pathology, but also the presence of a possible erosion at the site, since a slope and the detachment of the asphalt layer to the sub-base layer are notable. Suspicion of the motive will be given by the presence of an underground gallery below the section where the pathology is found.
